20mm Luxura Test Report

Number of tests to ensure the 20x200mm Luxura meets expectations and requirements for sale.

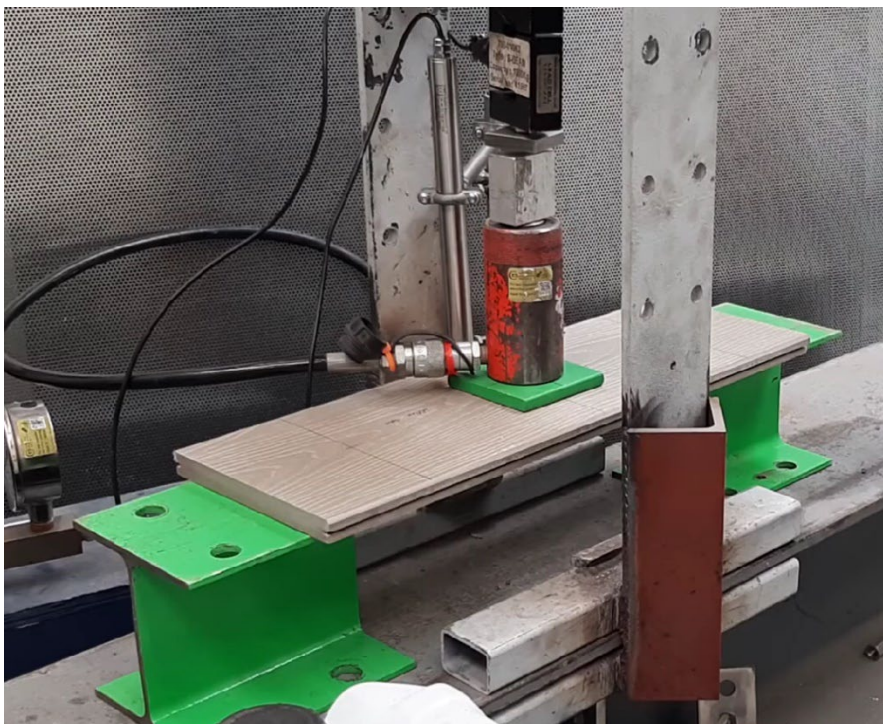
The first span tests were a 400mm span break test applied as a point load through a 100x100mm plate. The load is applied in the middle of the span with a hydraulic ram, a load cell was used to measure applied load while a probe measured deflection also in the middle of the span (See test setup below). The second span test is identical to the first but with a 550mm span. A 460mm test was also carried out later.

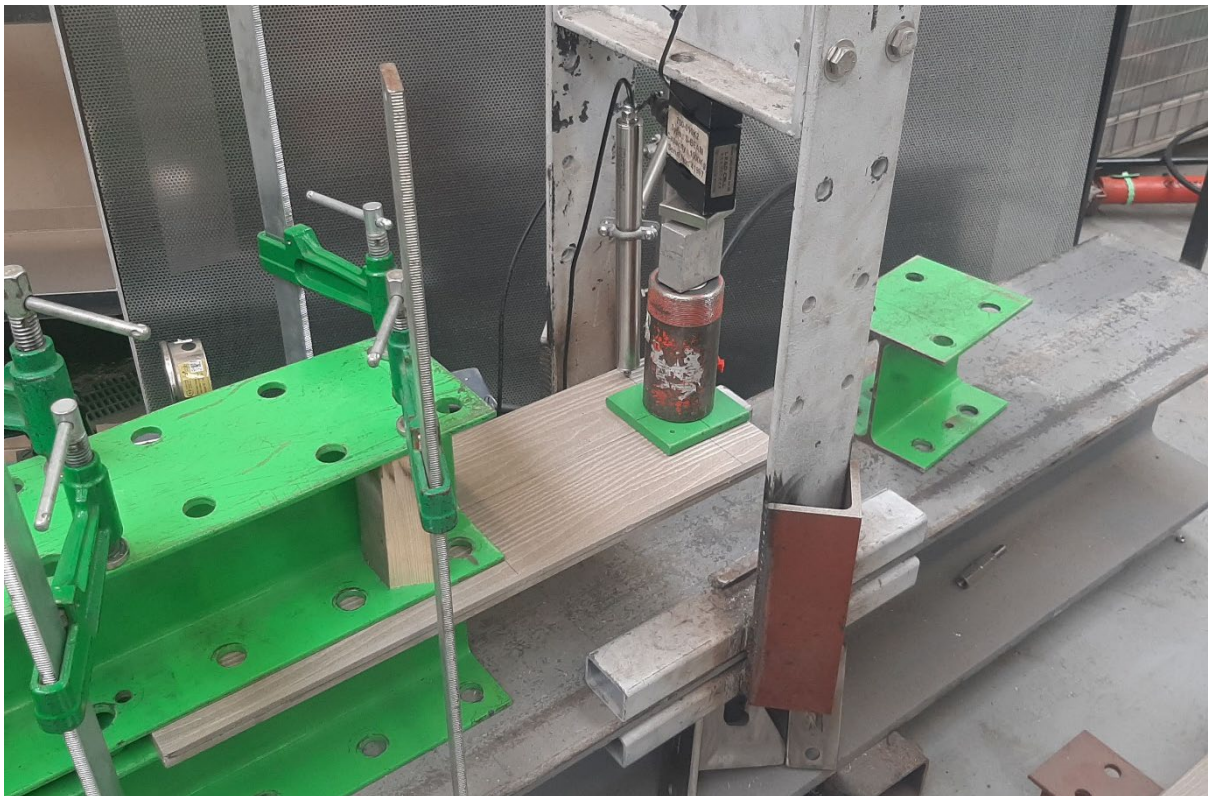
The Cantilever break tests are with both 250mm and 300mm overhangs applied as point loads. Load is applied to the end of the overhang with the full 100x100mm plate on the board, load is again measured with a load cell and deflection is taken with a probe on the edge of the board level with the middle of the plate (50mm from the end). The remainder of the 600mm (350mm and 300mm respectively) board is held between 2 steel beams, clamped down to the arm tester (test setup below).

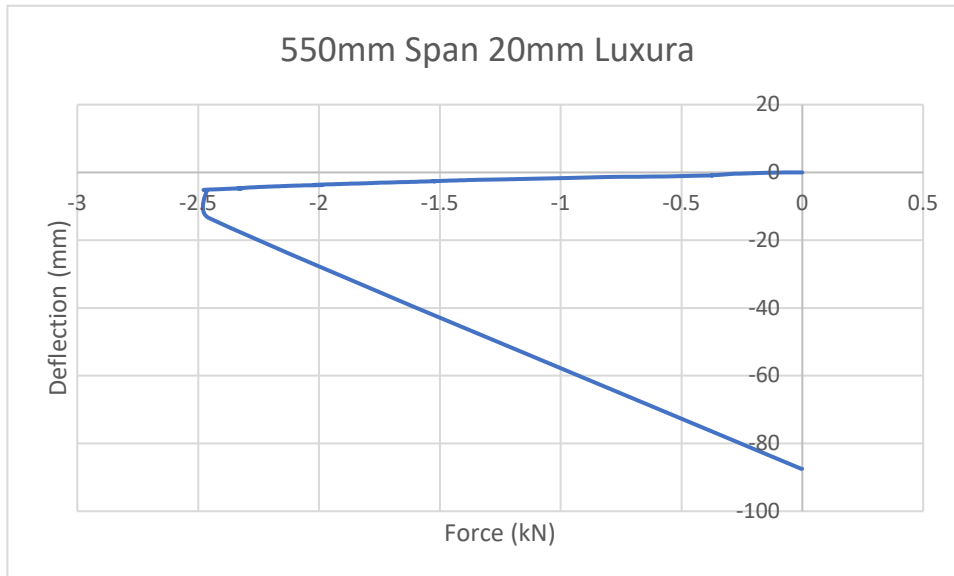
550mm Span Break Test

Deflection at 2kN = 3.73mm

Failure Load (kN)	Deflection at Failure (mm)
-2.463	-5.25

In conclusion, as expected 20mm Luxura with a width of 200mm performs much better than 20mm boards with a width of 144mm, although generally worse than 25mm thick boards at a width of 144mm. The 20x200mm wide board passes the 410mm span test easily, breaking at 3.37kN- these results are seen in bold. The 20x200mm wide board also passes the 550mm span deflection test whilst the 20x144mm fails.

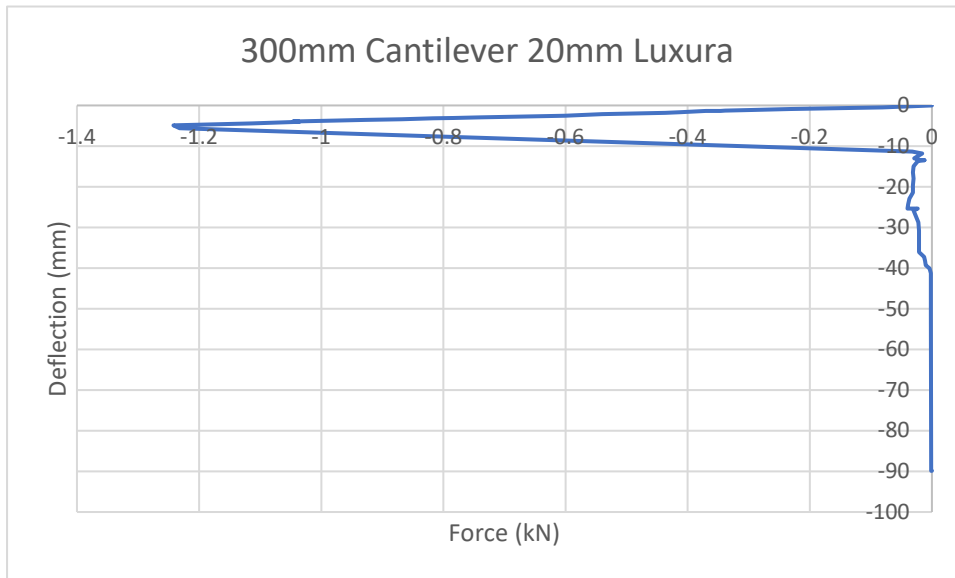
300mm Cantilever Test

Deflection at 2kN = N/A didn't reach 2kN

Failure Load (kN)	Deflection at Failure (mm)
-1.046	-3.96

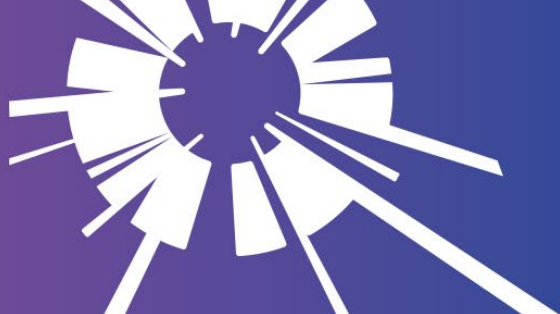
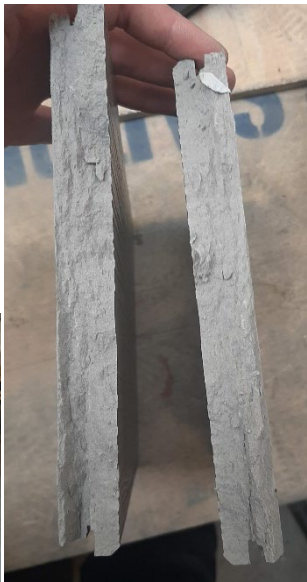
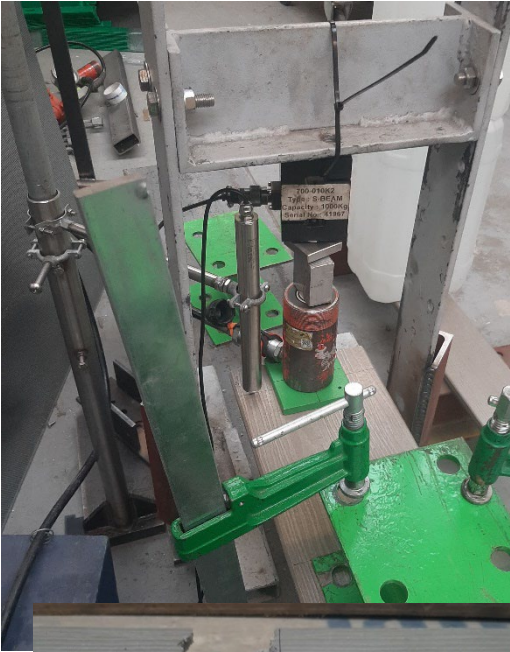
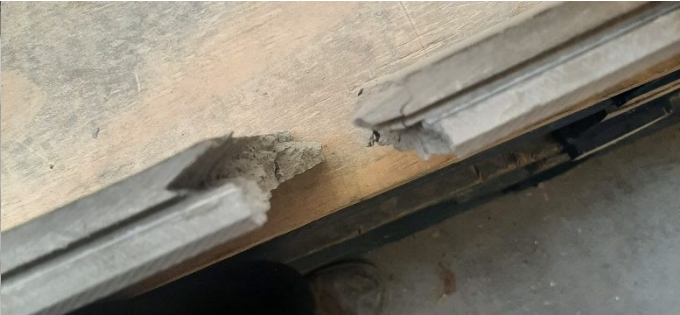
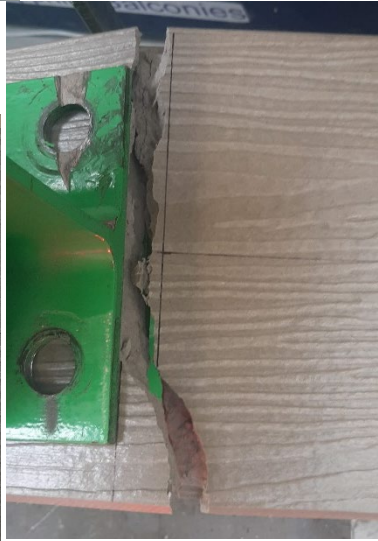
250mm Cantilever Test

Deflection at 2kN = N/A didn't reach 2kN

Failure Load (kN)	Deflection at Failure (mm)
-1.469	-3.26

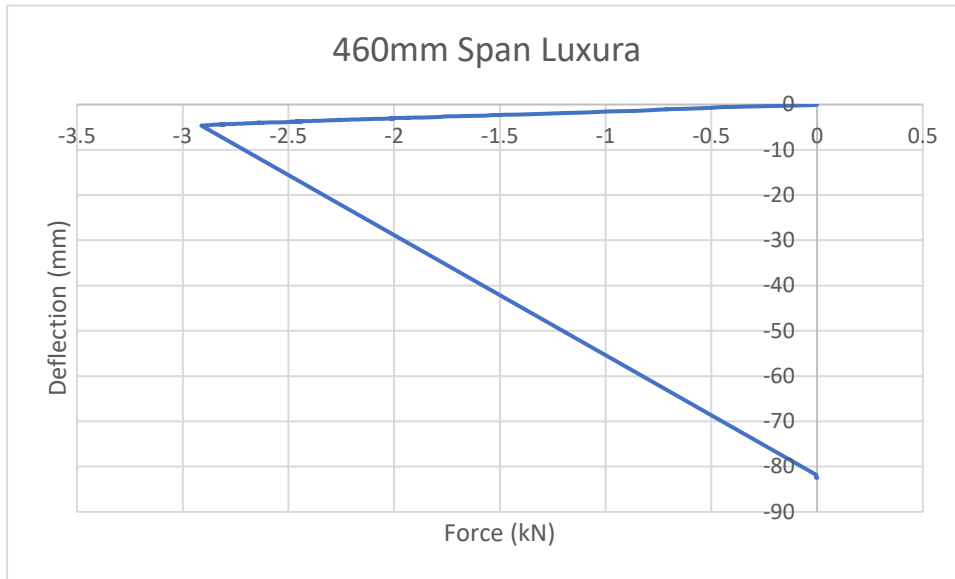
460mm Span Test

Deflection at 2kN = 2.98mm

Failure Load (kN)	Deflection at Failure (mm)
-2.912	-4.67

Please note that 460mm span testing is not included on this table as previously it was carried out to boards ripped down to 120mm wide.

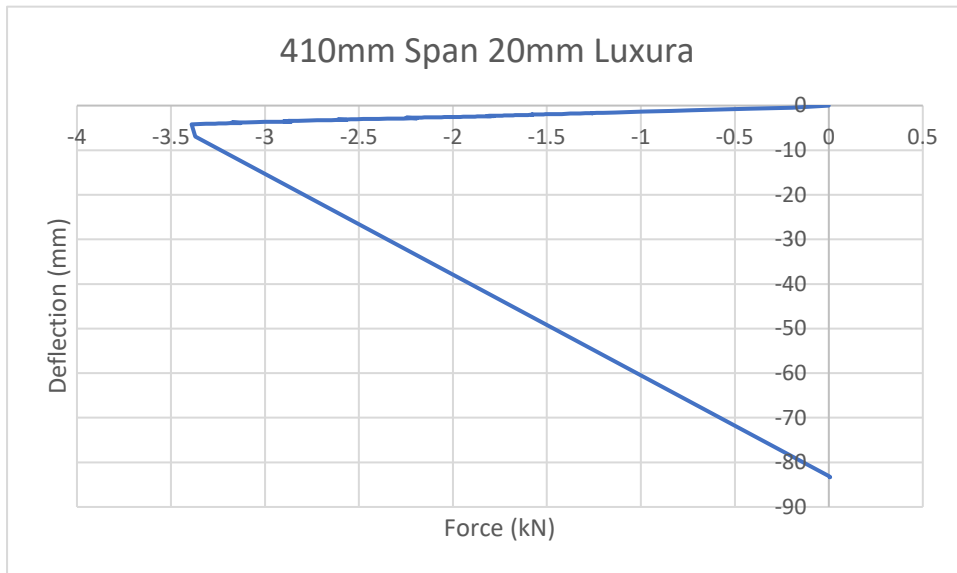
410mm Span Test

Deflection at 2kN = 2.55mm

Failure Load (kN)	Deflection at failure (mm)
-3.390	-4.22
